Upgrading a Drinking Water Membrane Plant with Ceramic Membranes, a Case Study

M. Shaw, G. Galjaard, H. Evans, J. Pressdee

Nanostone Water

Canyon Regional Water Authority(CRWA)

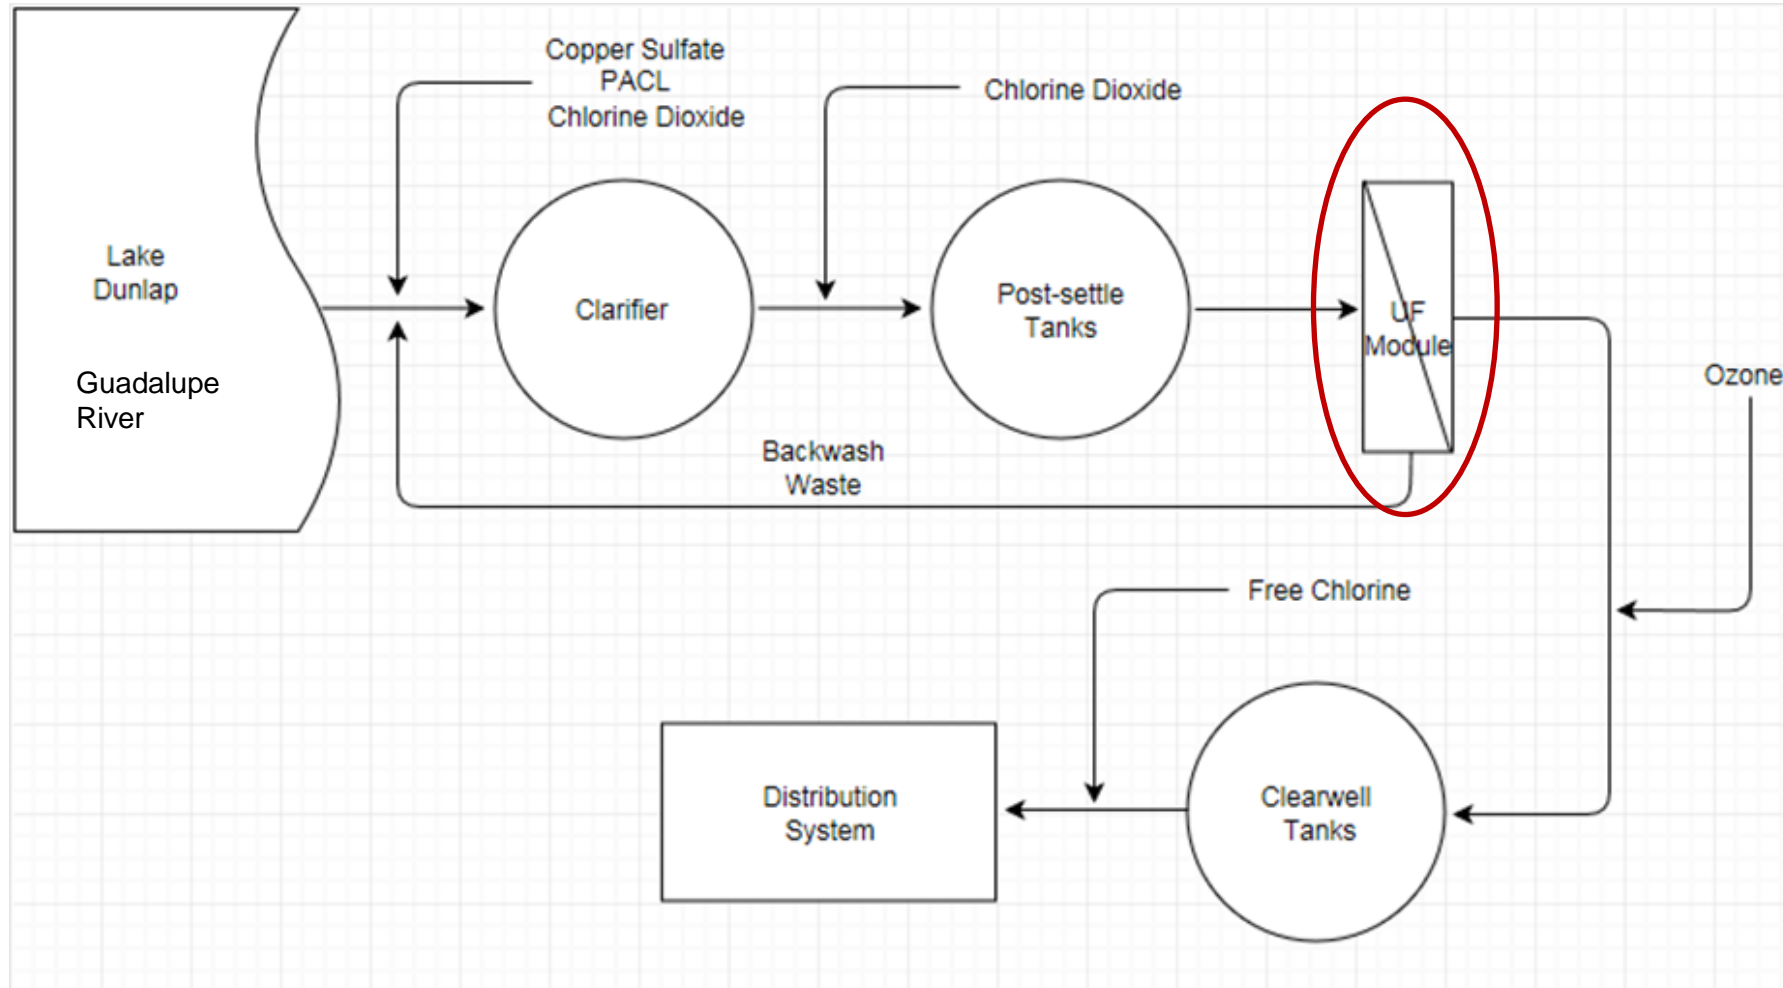
Operations rely on robust MF / UF System

Struggling polymeric MF system rendered the system unable to meet capacity

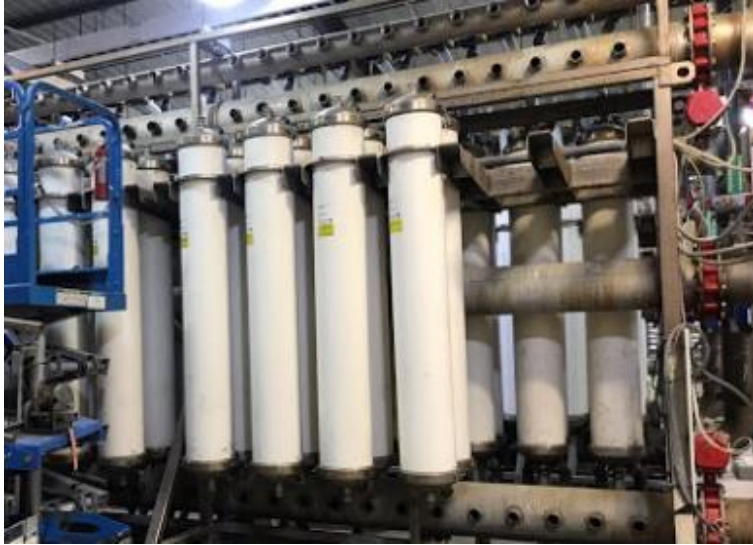
Direct retrofit of existing membrane system

One for one membrane replacement
utilizing the existing infrastructure
(racks, pumps, piping & valves)

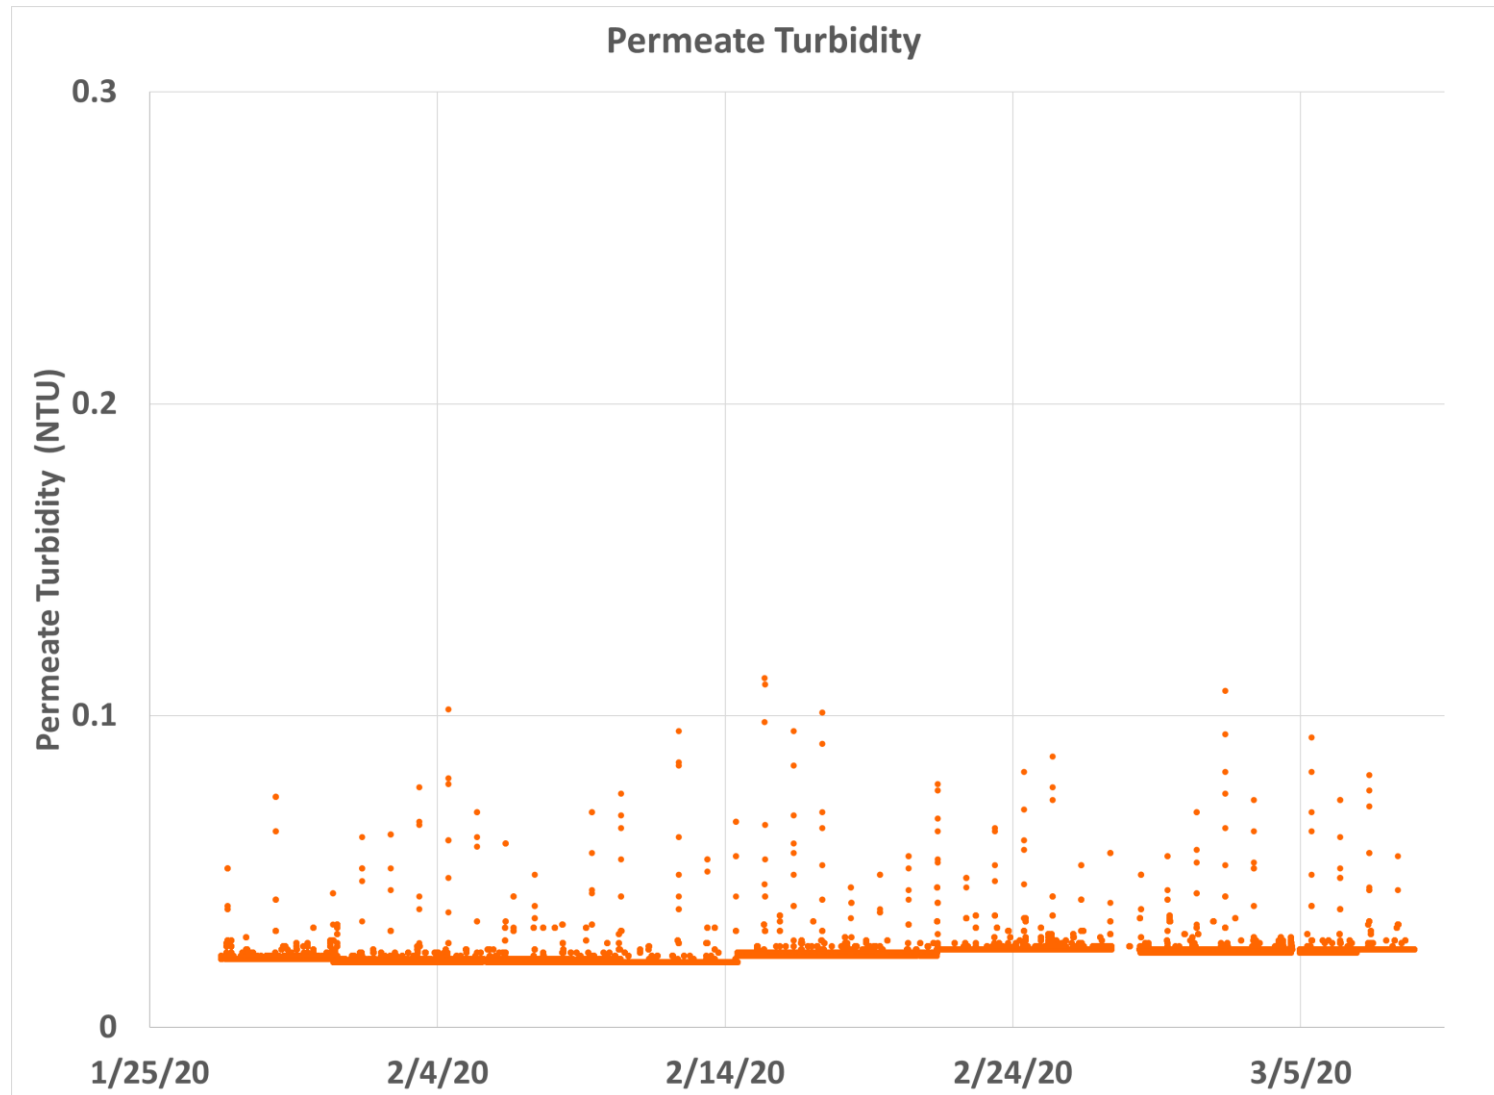
Stable water quality throughout study
