Upgrading a Drinking Water Membrane Plant with Ceramic Membranes, a Case Study

Canyon Regional Water Authority(CRWA)

- CRWA's Lake Dunlap Water Treatment Plant is located in **New Braunfels, Texas**
- The plant treats surface water from the **Guadalupe River**
- Licensed to produce 14.4 MGD (55 MLD)

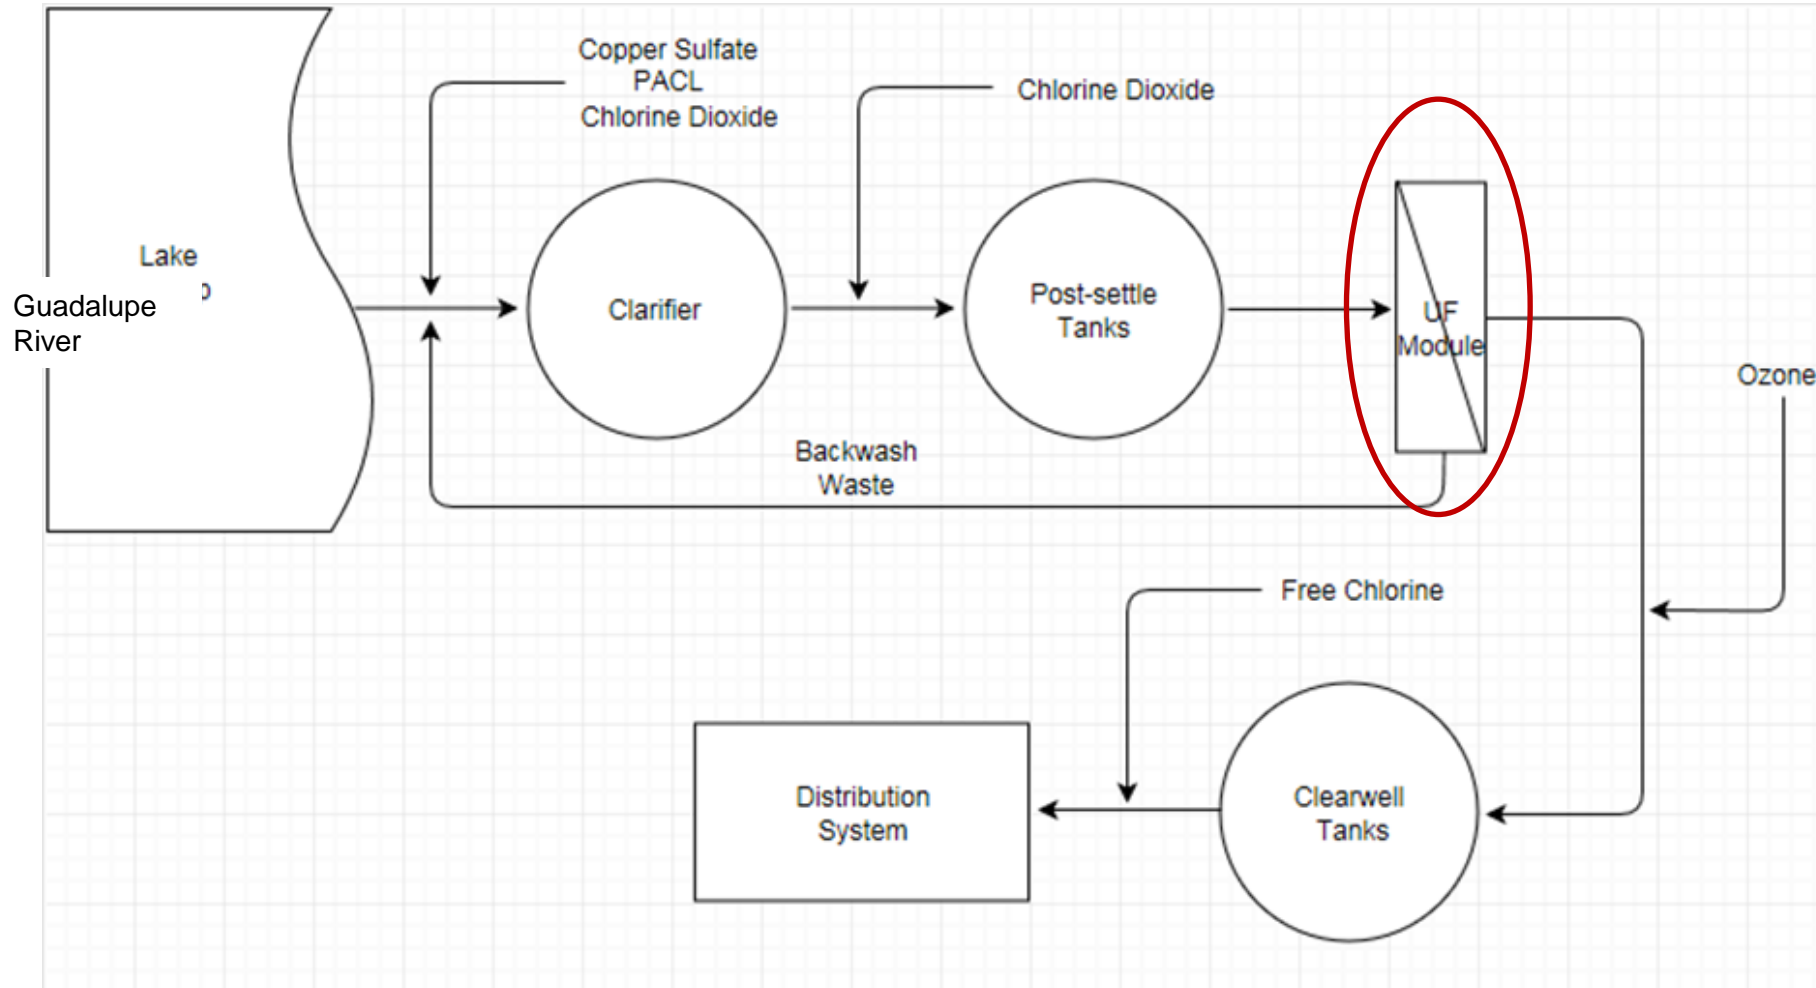
Operations rely on robust MF / UF System

Struggling polymeric MF system rendered the system unable to meet capacity

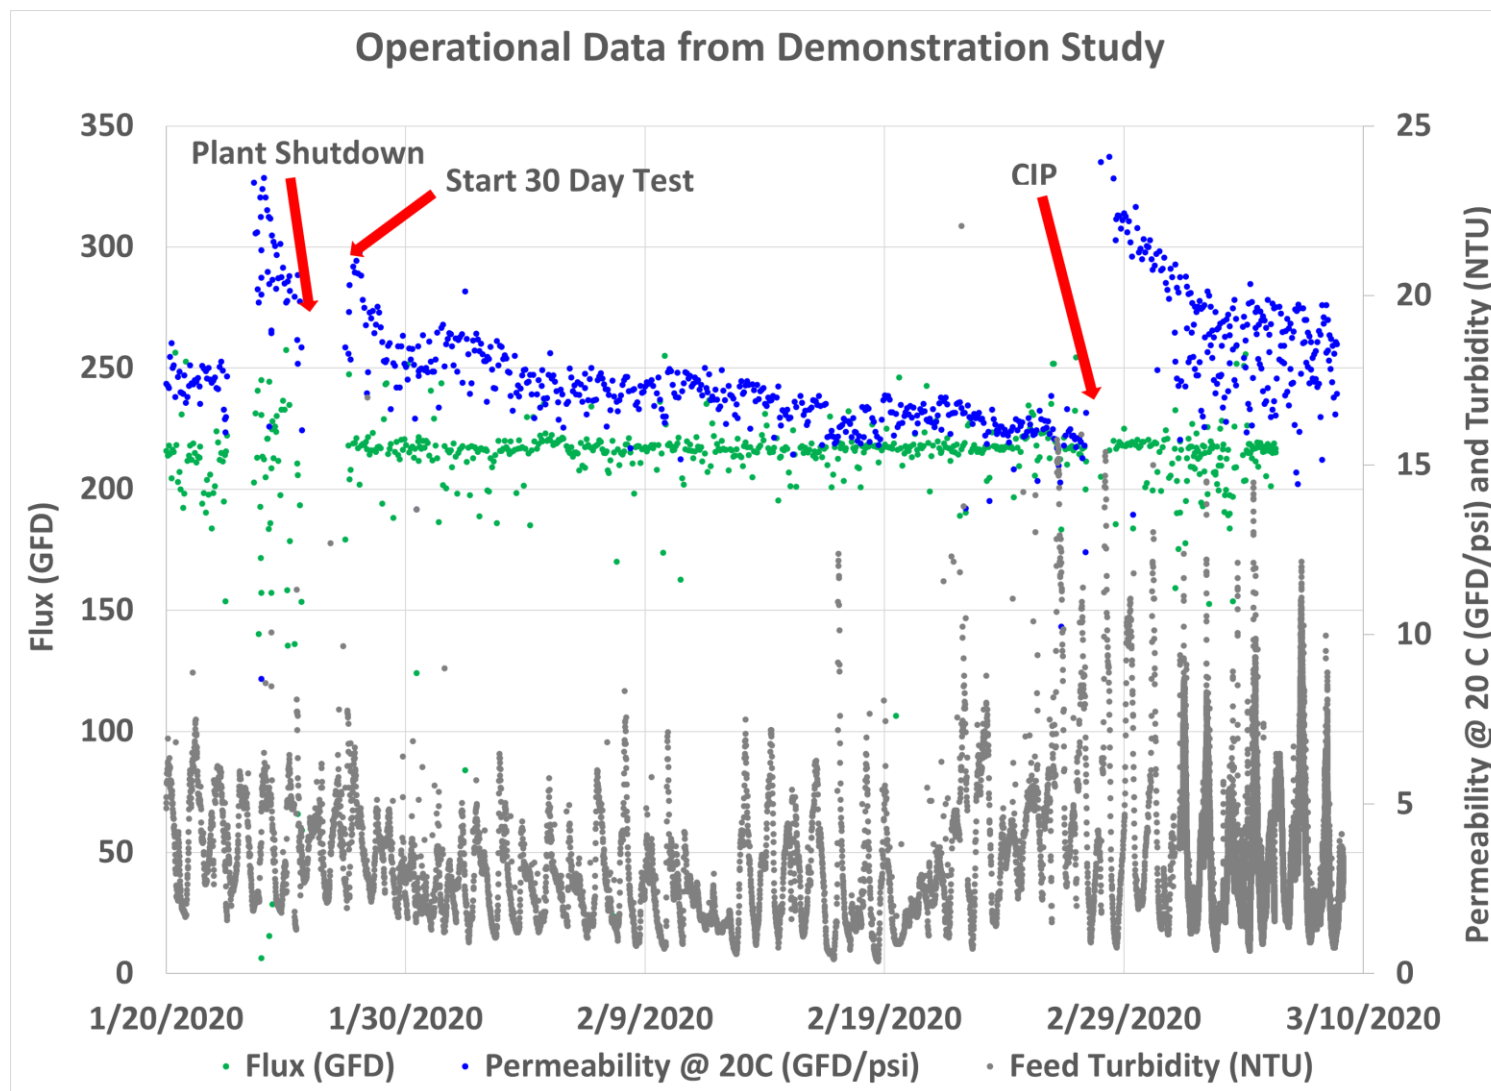
Sustainable operation through demonstration study
